## SECOORA Projects Updates

# SECOORA Regional Assets

- 2016-17 project goals: keep coastal stations, moorings, and HF Radars operational.
  - Overall our PIs have been successful
    - New HFR installation
    - Upgrades to stations
  - There have been a few challenges
    - Hurricane Matthew
    - Erosion problems at HFR sites
    - Ship strikes for offshore moorings

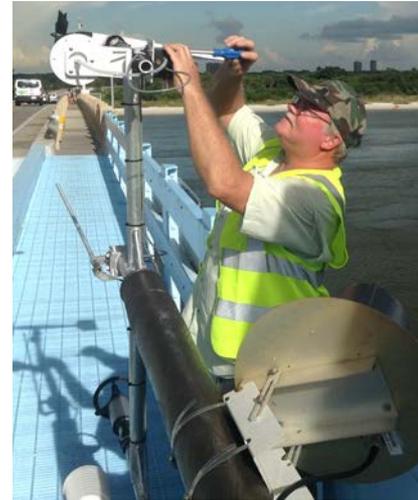
- Big Carlos Pass, FL coastal site (USF: Luther)
- Rebuilt - replaced the MET mast on the drawbridge deck, replaced all sensors
- Enhancement - added a Vemco fish tag recorder and a passive acoustic sensor with Jim Locacsio (Mote Marine Lab).

Wiring sensors

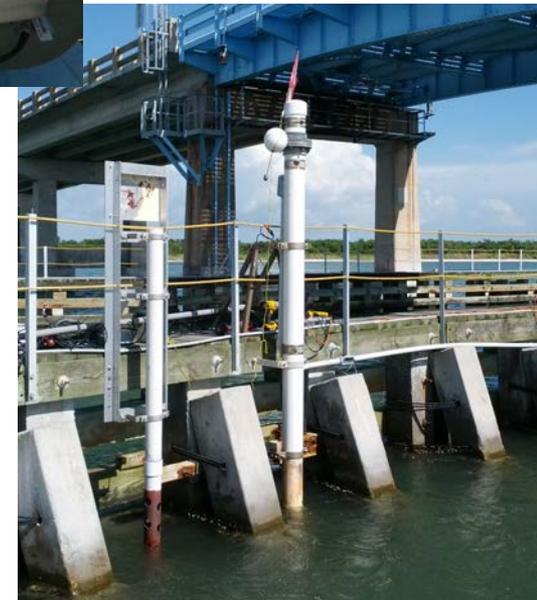
Newly mounted well

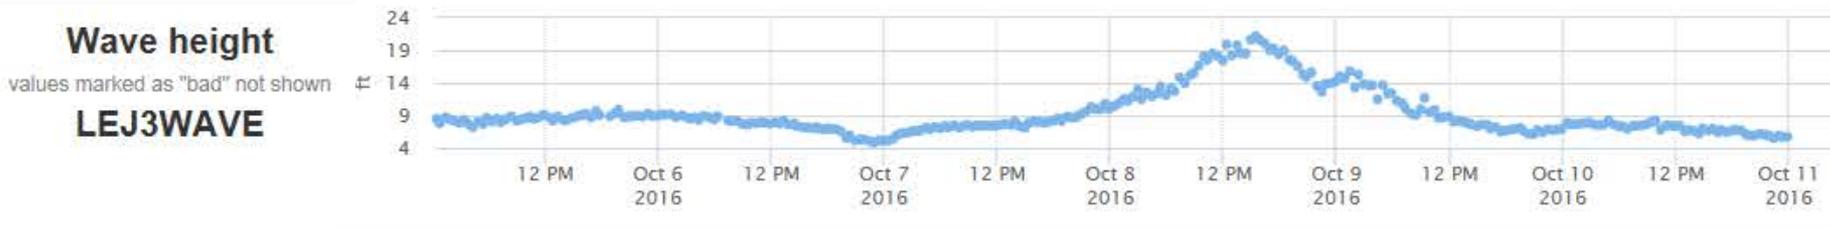
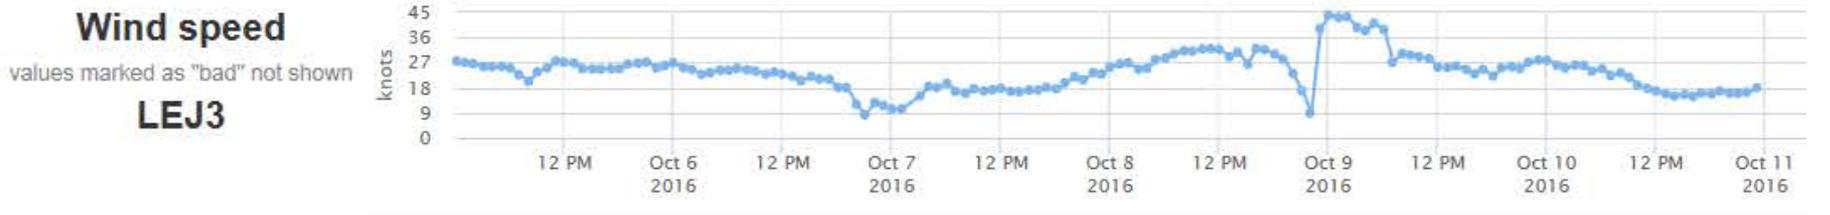
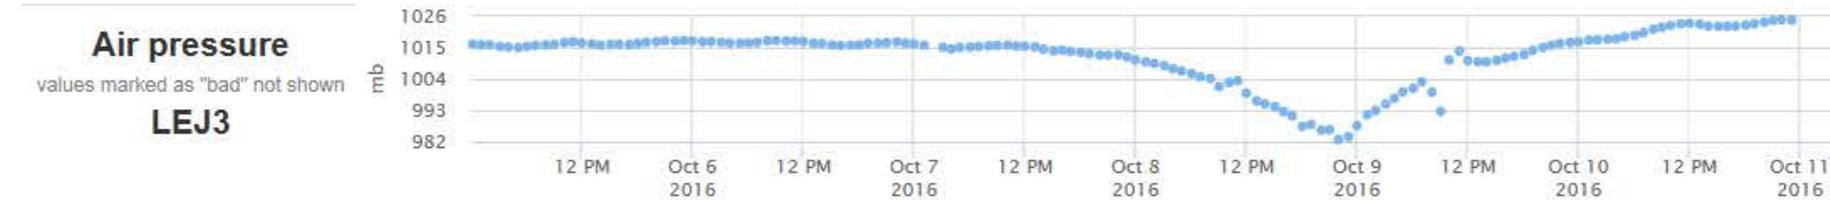
UNCW (Leonard & Dorton) moorings faired well during Matthew.

Outer Onslow Bay, NC: LEJ3 and LEJ3Wave data from Hurricane Matthew, October 5-10, 2016

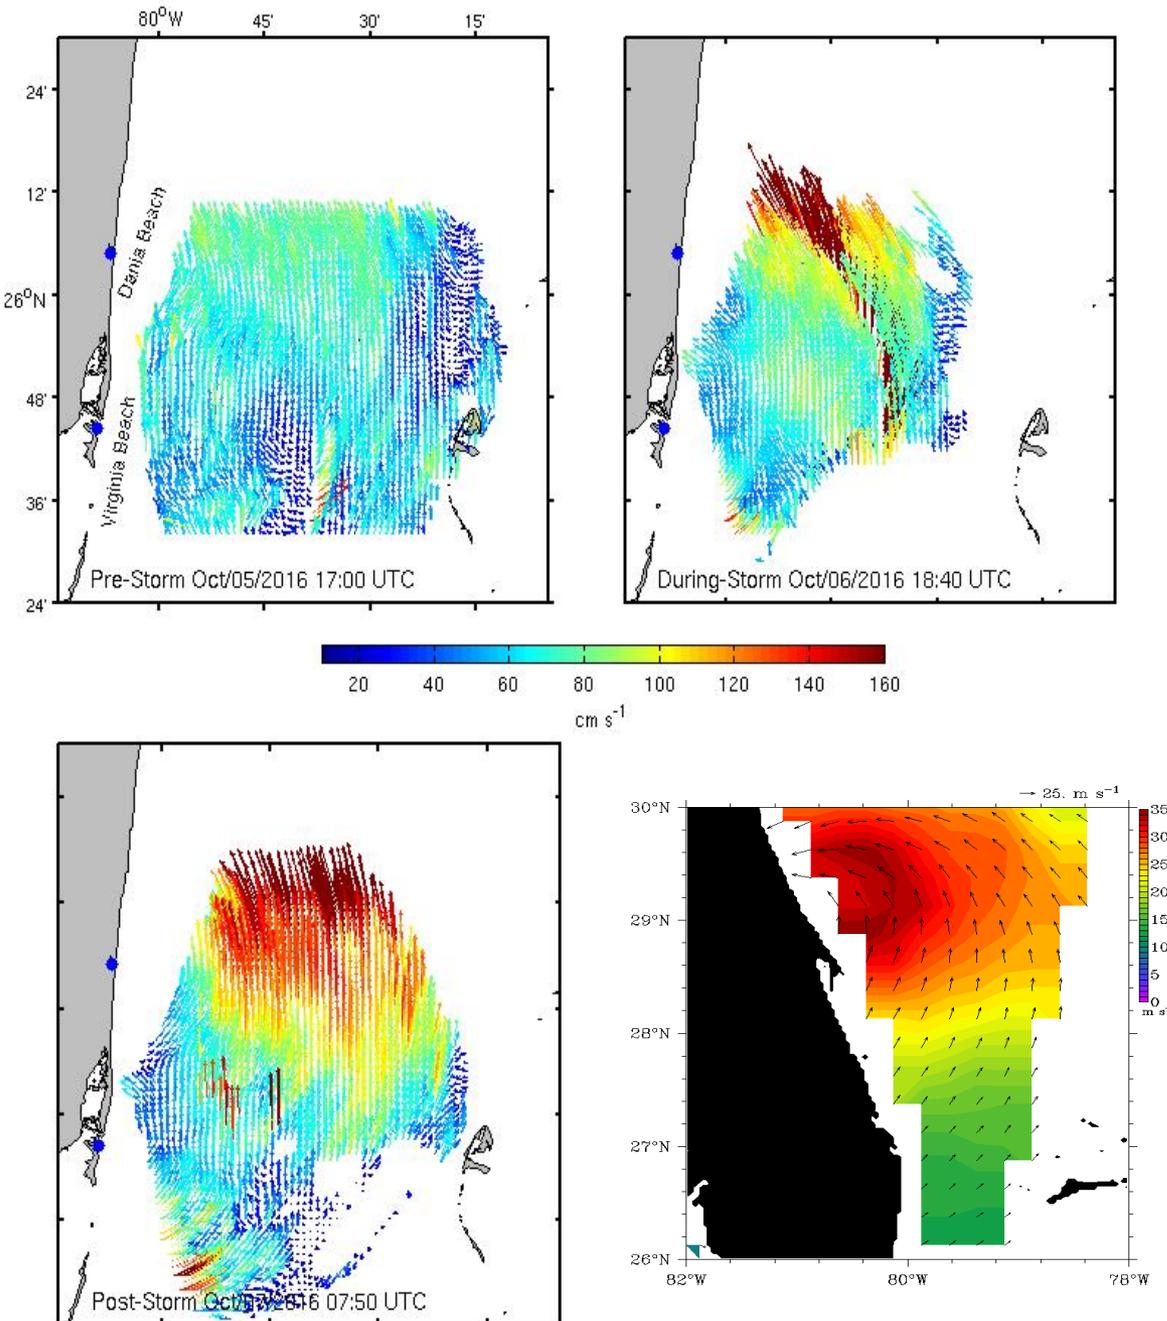
Pre-Matthew (upper left),  
Matthew (upper right), and  
Post-Matthew (lower left)  
surface currents from WERA.  
Notice the interference  
patterns in the storm panel.  
ASCAT image in the lower  
right panel (m/s).

Winds from Fowey Rocks  
during Oct/05 (Pre-storm;) NE  
direction 5 to 10 m/s, during  
Storm was crossing south  
Florida latitudes; N direction  
12 to 15 m/s; and,  
next 12 hours after; W-SW  
direction 14 to 20 m/s.

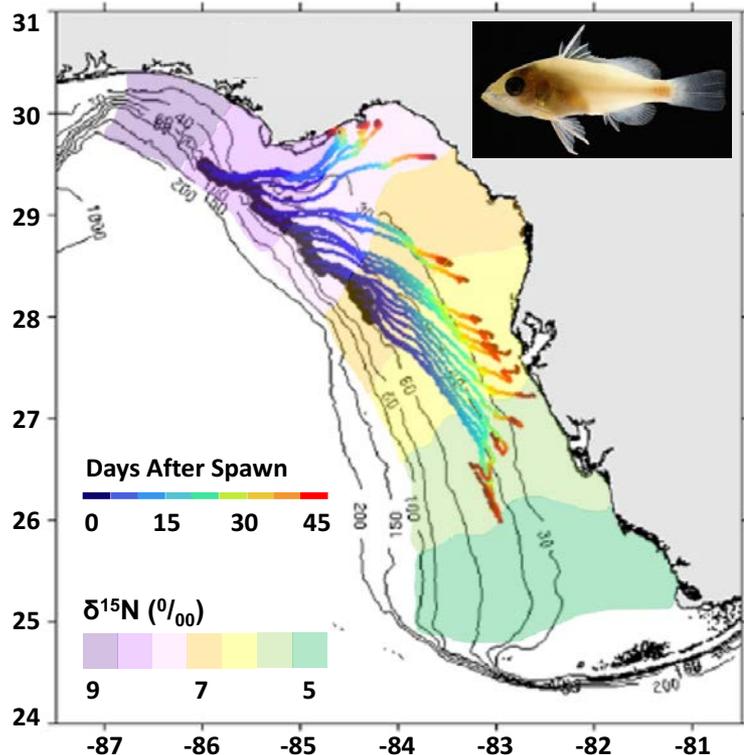
Ecology is fully 3-D. USF (Weisberg) moorings give the vertical dimension of the flow field and water properties.

Solution to the gag grouper recruitment conundrum: Juveniles get from offshore spawning to nearshore settlement along the bottom.

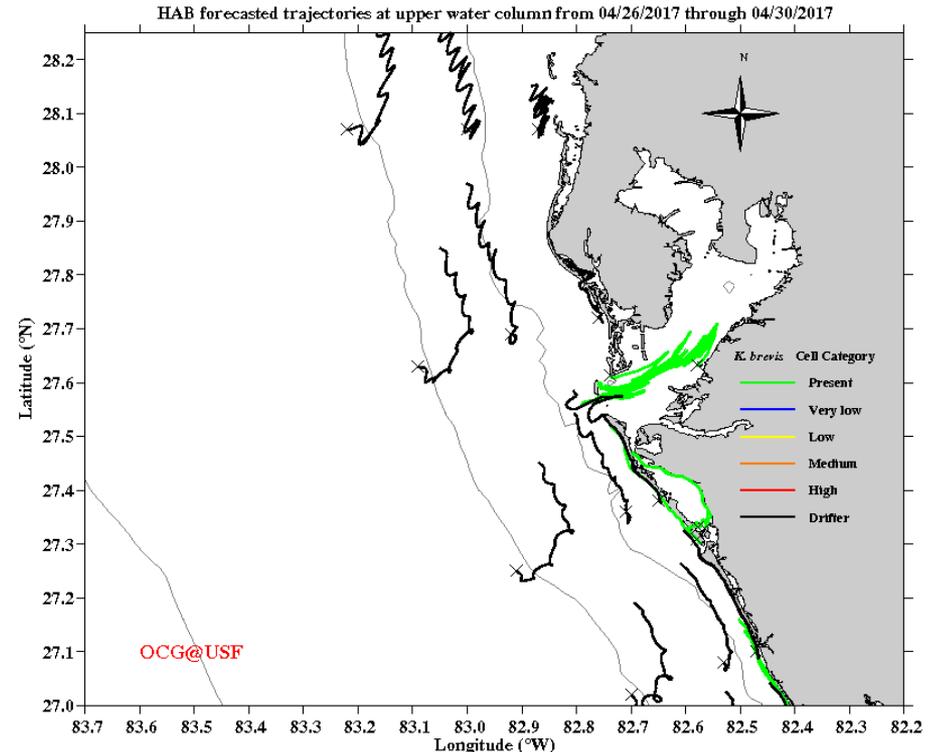
Seasonal prediction and short-term tracking of red tide. Moored observations used for model testing.

USF/FWC WFCOM *K. brevis* red tide tracking tool.

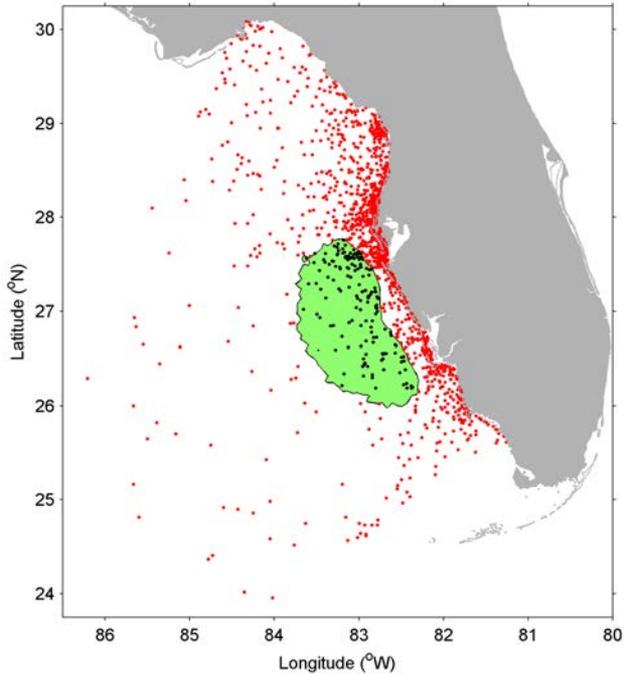
HFR (USF: Weisberg) used in SAR. The WFS leads the USA in **SAR Cases**.

**Red dots** indicate WFS SAR cases. **Green region** indicates potential HFR coverage.

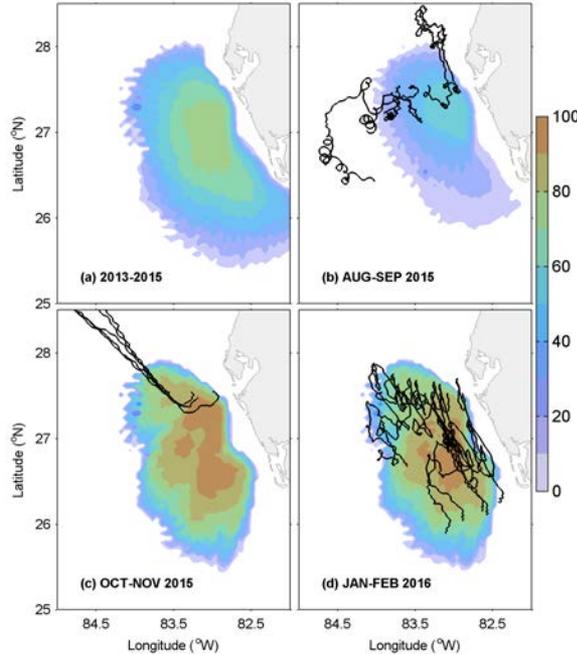
Drifter experiments show WFS coverage to be inadequate to support SAR.

HFR coverage for each of 4 seasonal drifter deployments.

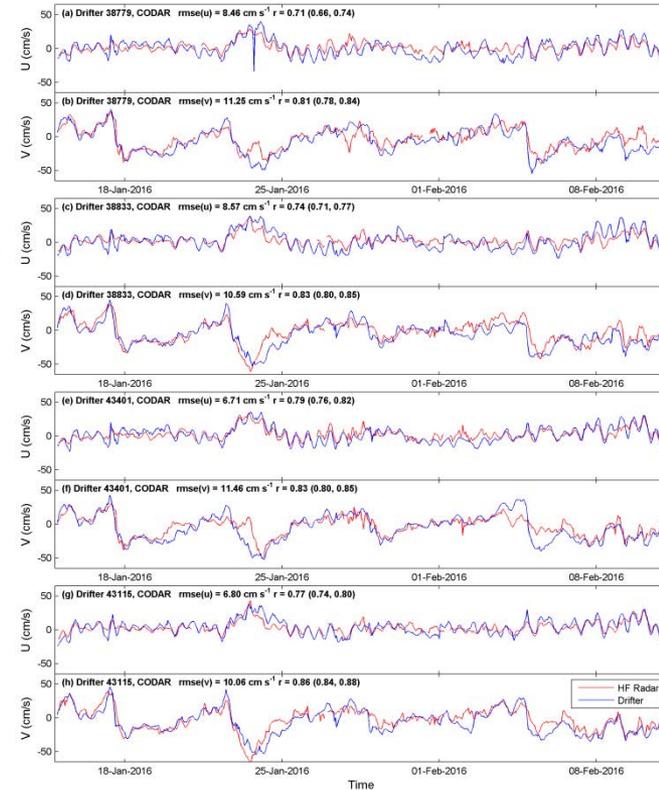
Drifter experiments show the efficacy of HFR for SAR when coverage exists.

**Drifter/HF-radar** velocity component comparisons.

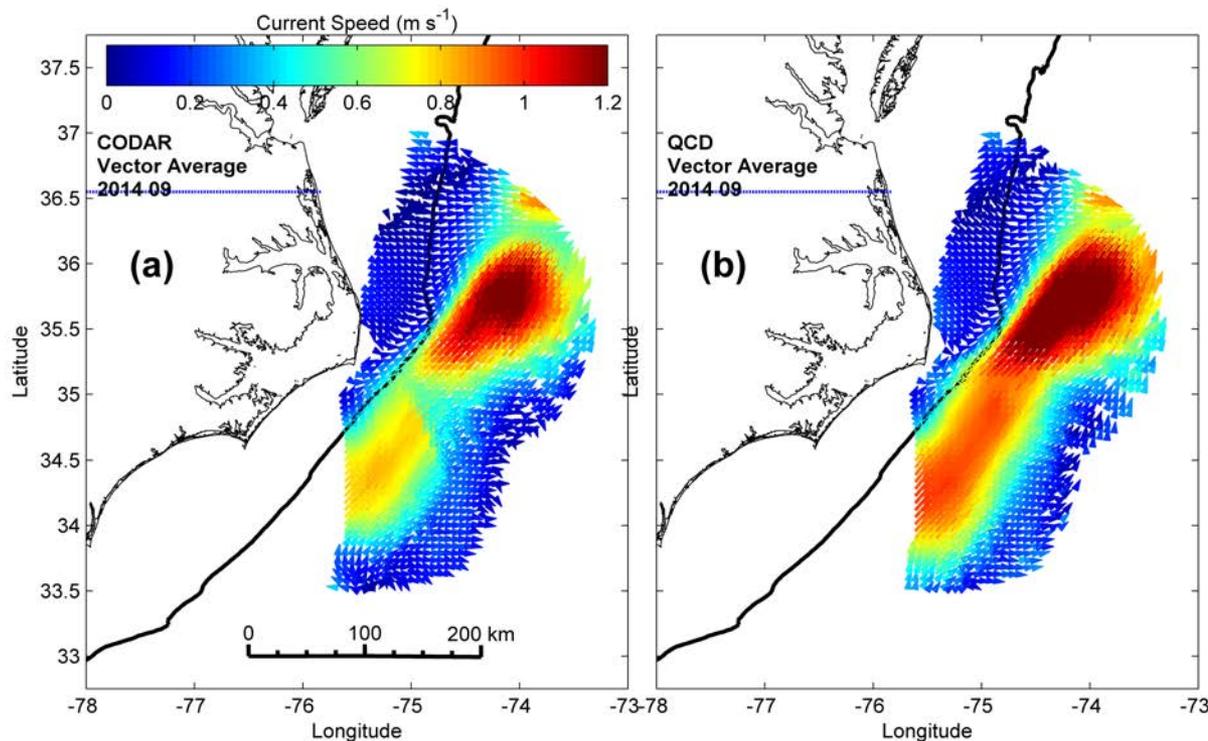
- Implementation of QC standards
- a) before b) after
- Note increase in speed of Gulf Stream and elimination of velocity jump in QC'ed field

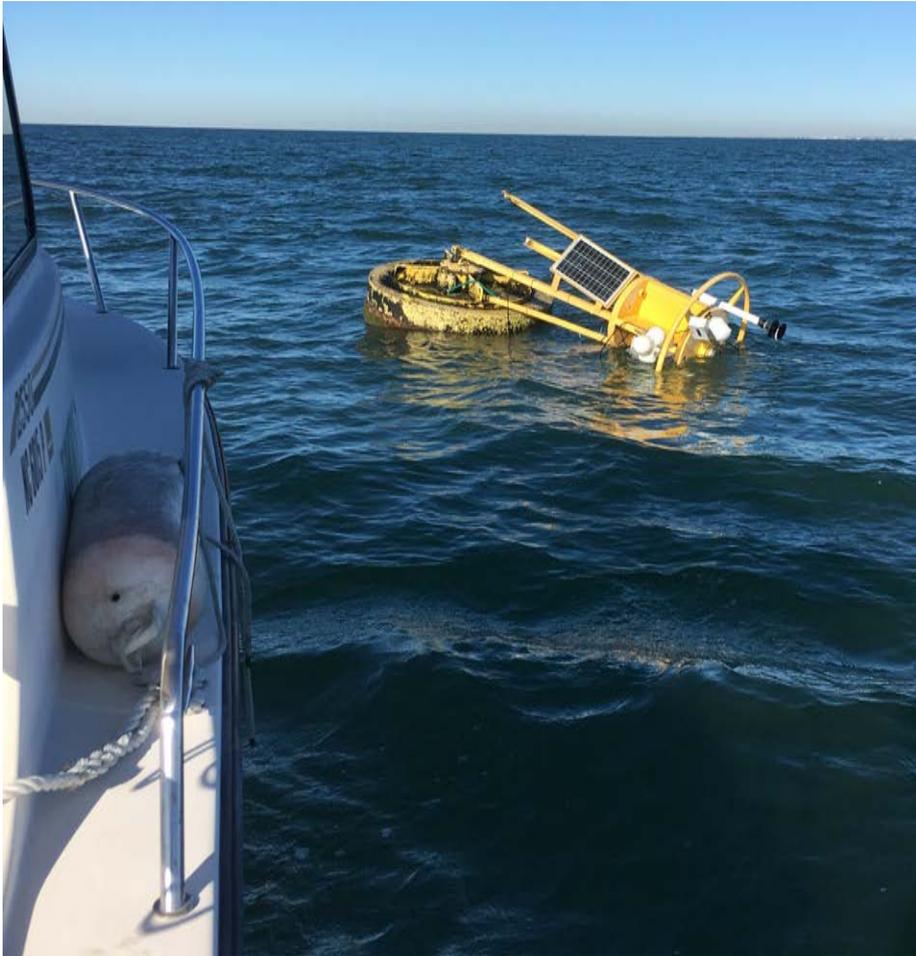
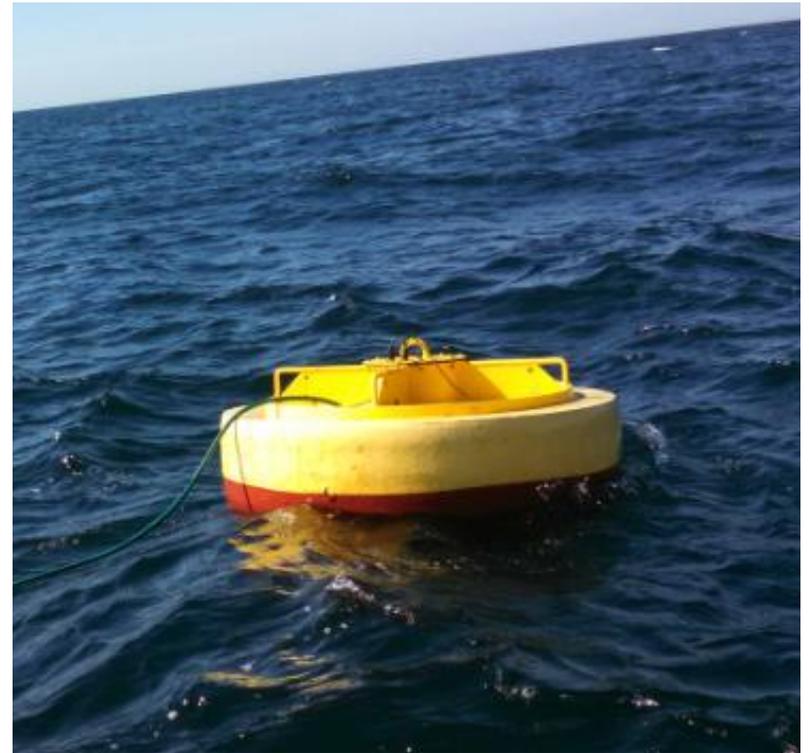
UNCW: Ship Strikes

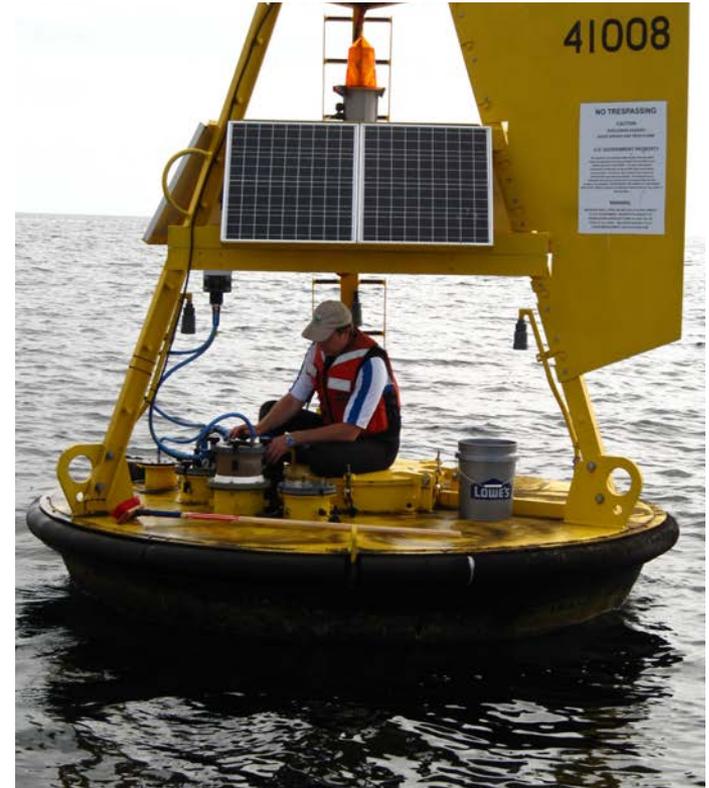
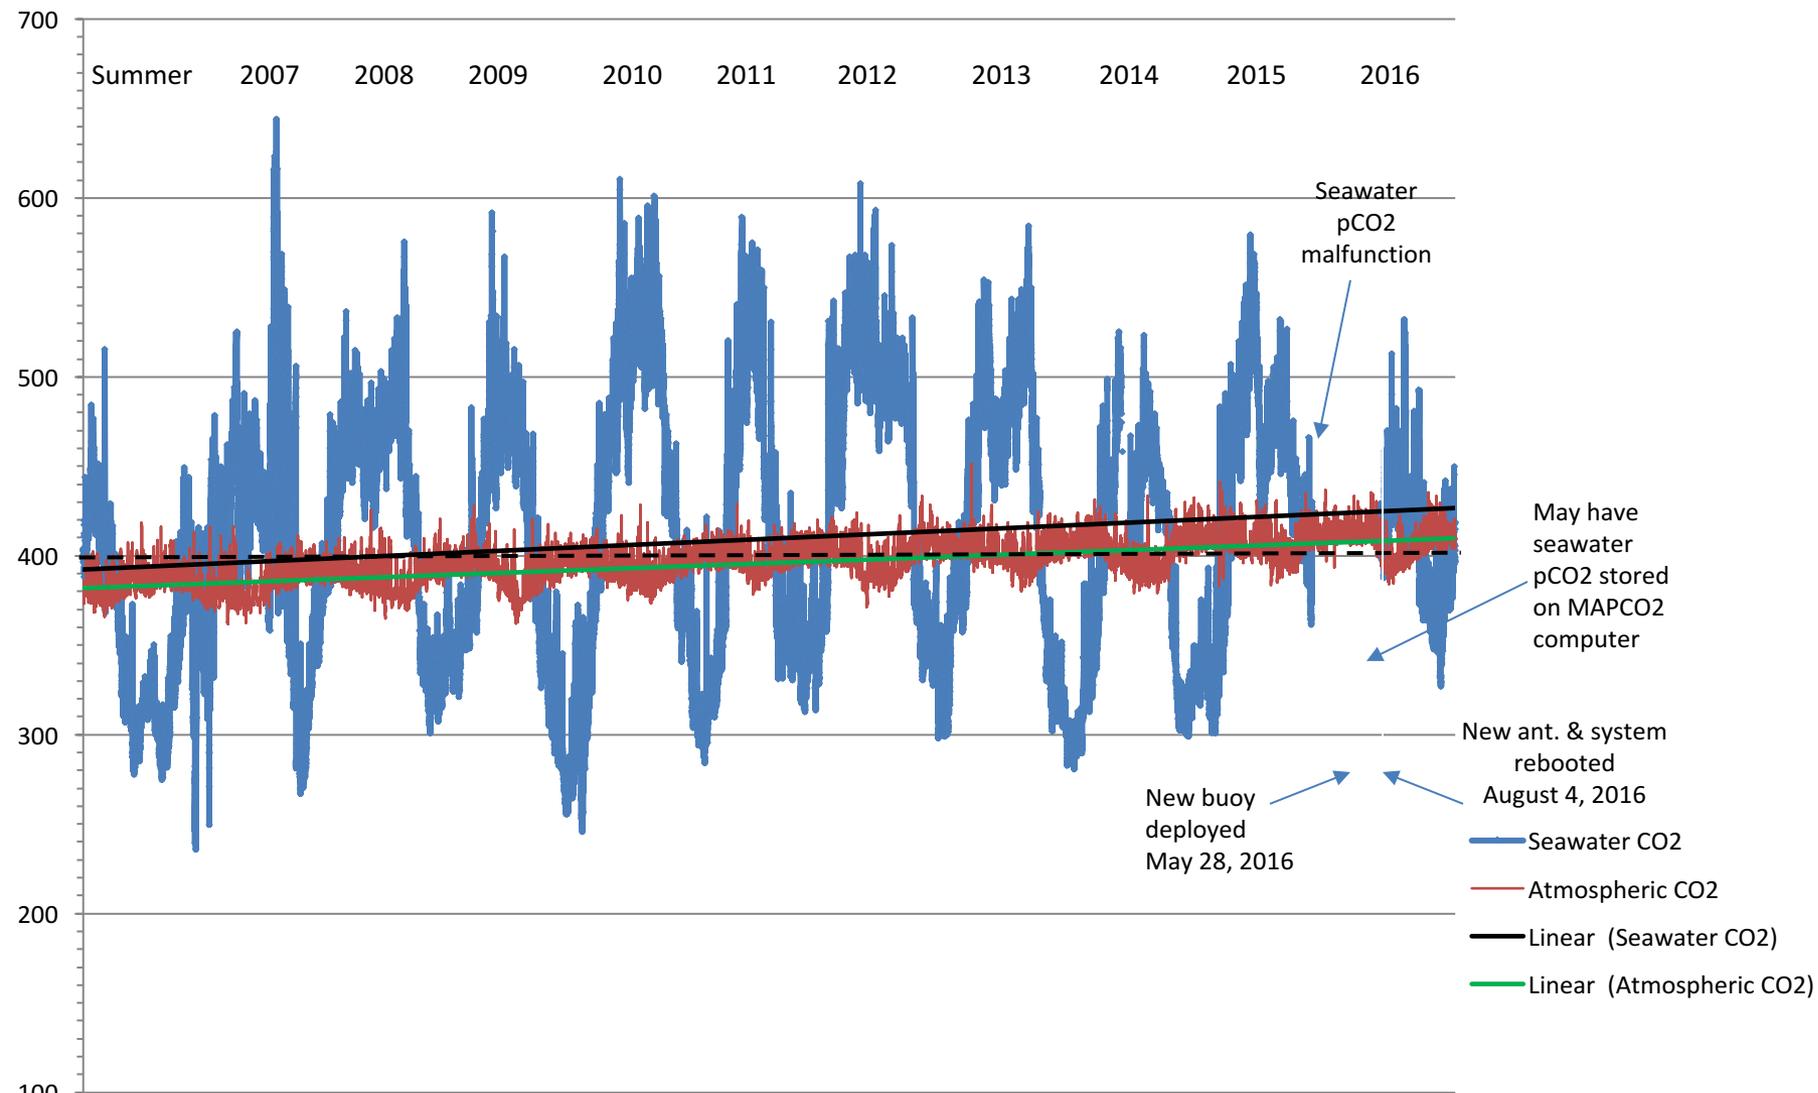
- January – Seawater pCO<sub>2</sub> malfunction
- May – Buoy 41008 replaced. All new MAPCO<sub>2</sub> instrumentation. System not transmitting.
- August – Replaced battery pack on MAPCO<sub>2</sub> and installed new GPS/iridium antenna. Reboot system.

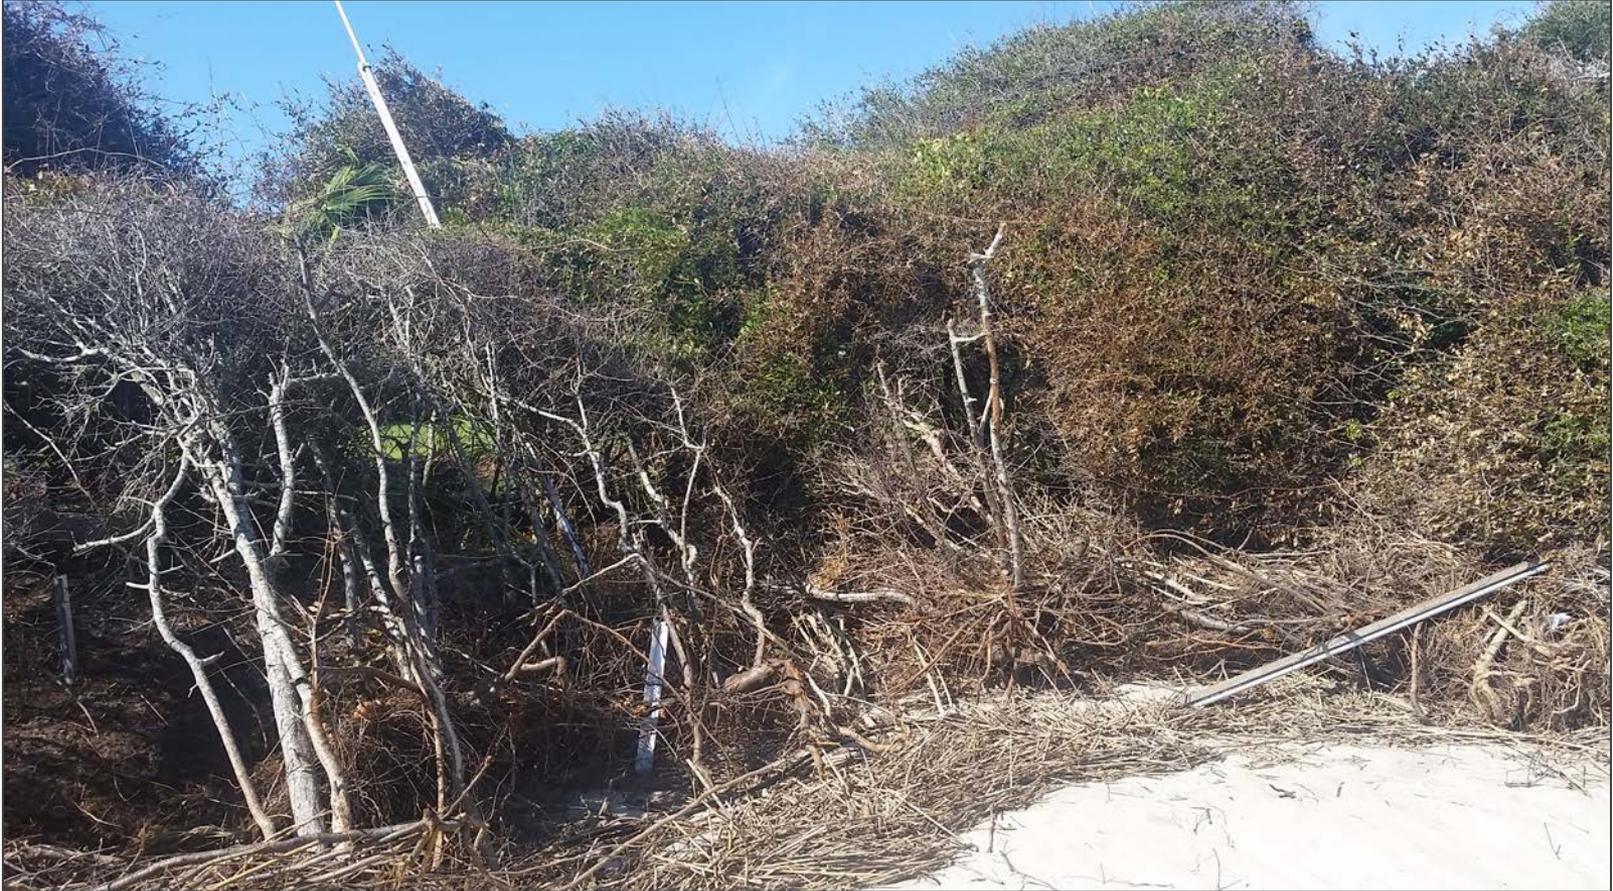
- operation resumed shortly after power was restored at Jekyll Island, GA with reduced number of antennas
- Refurbishment/replacement of damaged poles/coils/cable connectors is ongoing

Tx site disarray (photo: Dana Savidge)

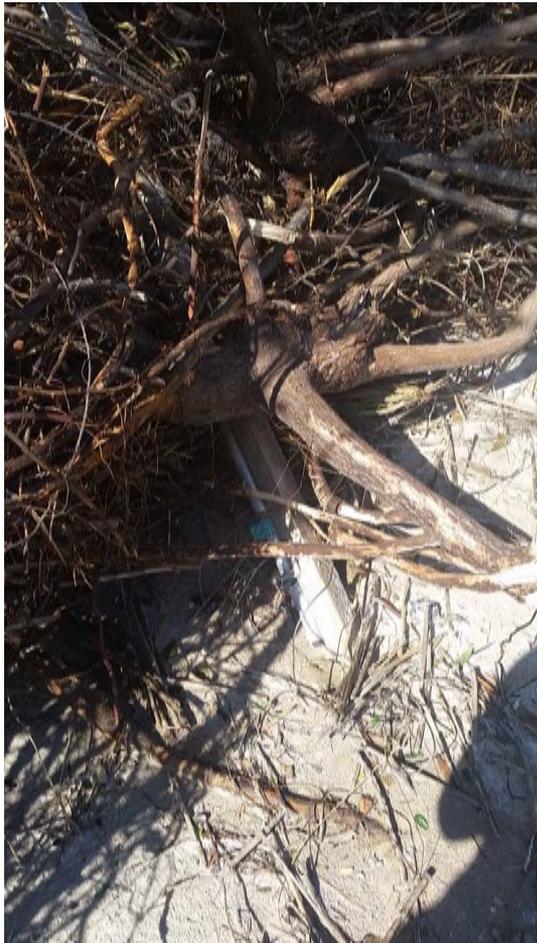
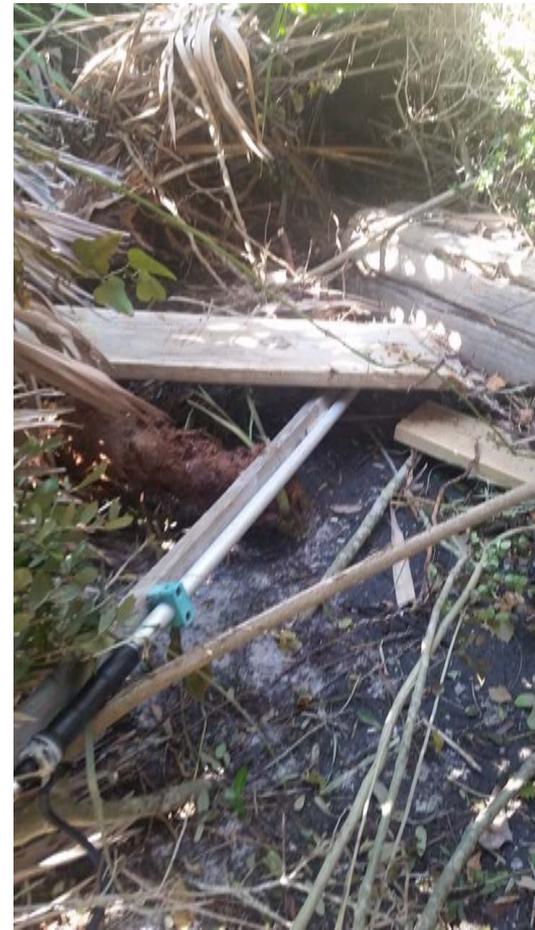
Buried and crushed antennas (photos: Dana Savidge)
